March 11, 2019

Scott D. Portzline
Eric Epstein
Three Mile Island Alert
4100 Hillsdale Road
Harrisburg, PA 17112

SUBJECT: 10 CFR 2.206 Petition on Apparent Violation of 10 CFR 50.9

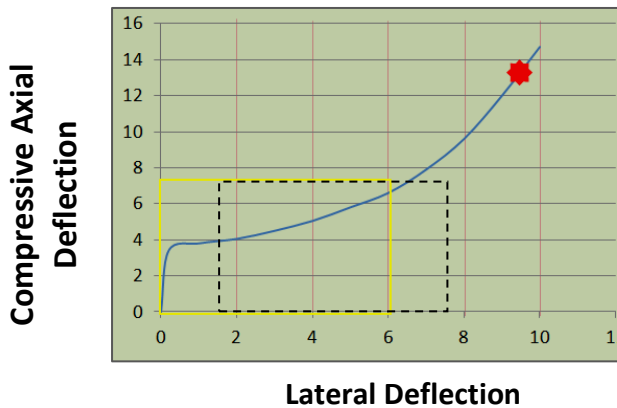
Exelon's graph¹³ on steam tube deflection + extended extrapolation

The steam generators steam tubes made from metal Alloy 690 are bowing under normal operating temperatures. This is because the steam generators are experiencing unexpected thermal expansion. This unwanted bowing was determined by the manufacturer AREVA to be attributable to three root causes:

Exelon's original graph is bound by the dotted lines on the lower left. The graph has been extended here by TMI Alert to extrapolate how great the lateral deflection or bowing would be if temperatures rose to 1100°F degrees as marked by the red star. Normal operating temperatures are ~ 550°F. An analysis is needed to determine the accuracy of this projection because the actual value is not known.
